# Seismic assessment of a dome structure with minarets as secondary elements: The case of Soltaniyeh Dome in Iran

Arezu Feizolahbeigi<sup>\*</sup>, Rafael Ramirez, Paulo B. Lourenço

The Soltaniyeh Dome, located in Iran, was built in the 14th century as a mausoleum. The building possesses several distinctive features that categorize it as a unique masterpiece of Iranian architecture. Notably, the double-shell dome of the structure represents a particular dome construction technique, in which the two parallel shells are connected through a network of ribs. This research aims to assess the seismic performance of the dome and its surrounding minarets as secondary elements. The methodology of this work starts with a historical survey of the building and its context followed by a review of the state of the art, preparation, and calibration of three-dimensional numerical models according to the defined scenarios, and performing seismic analysis including pushover analysis and limit analysis to assess the seismic behavior of the entire structure. The results from seismic analyses provide the collapse mechanisms of the entire structure. Additionally, minarets were identified as the most v

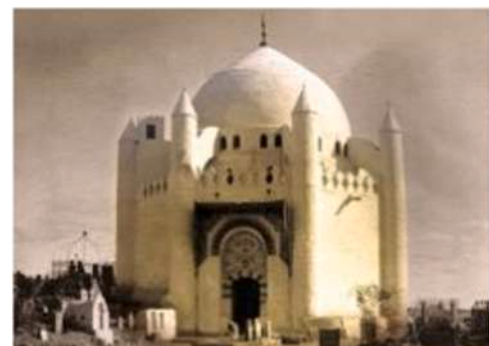
**Fig. 6.** Similar configuration of the shrine built in Saudi Arabia by Iranian master builders [64].

The different facades of the mausoleum are presented in Fig. 5. In the northwest side of the mausoleum, a small mosque was built approximately a century, after the construction of the mausoleum (Fig. 5b). The presence of the eight minarets is a unique characteristic of Soltaniyeh mausoleum since this form has not been reported in any other building in Iranian architecture. Although some shrines built by Iranian master builders in Saudi Arabia share a similar form, albeit on a smaller scale, but these shrines were tragically ruined after 1925 due to religious beliefs (Fig. 6).

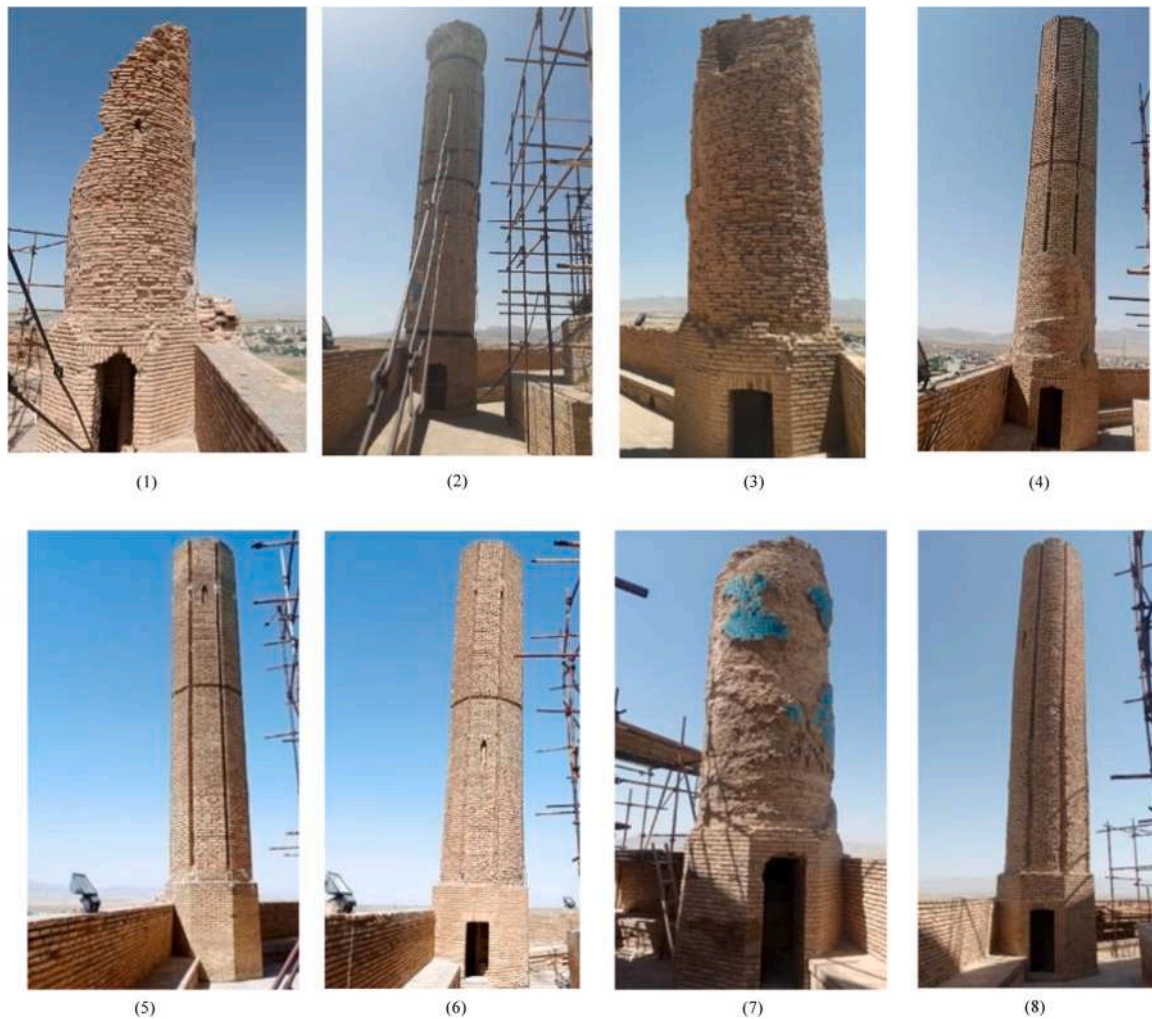
**Fig. 11.** Global conservation works and structural retrofitting of the eight minarets.

occurred over centuries (Fig. 11). Erosion and mortar loss are evident in the remains of the original minarets where covering tiles have also detached completely. Still, the overall structural condition of the building seems suitable. In the interior spaces, instances of material loss at the plinths of walls were observed, and general cracking was detected on the decorative materials covering the walls. The predominant damage in the
